CASE – ECOJET

At the DAMRC Technology Center the **Hermle C22U 5 Axis milling machine** was an important part of solving the challenge of machining a hole in an Inconel 718 turbine in the ECOJET project.

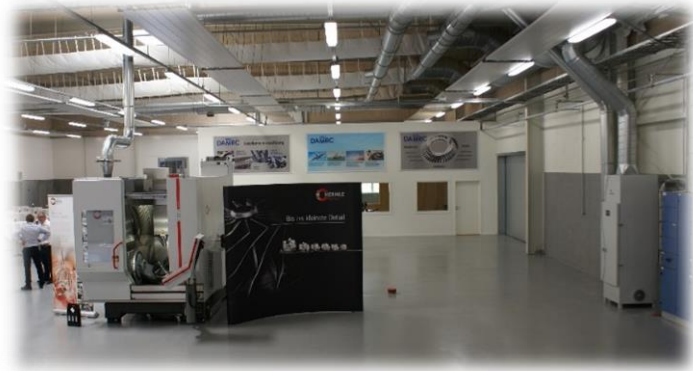
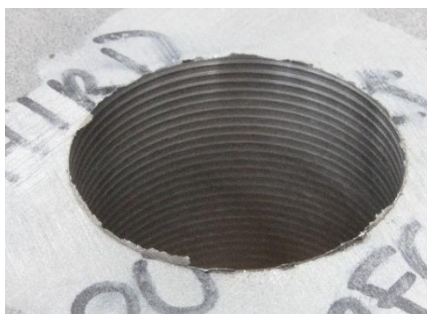
As this is a very hard to machine material, drilling was ruled out as an option. A circular ramping was used instead, where a spiral movement of the tool enables to machine this hard material. Moreover, it was also found, that ceramic tools offer a much higher productivity than conventional (carbide) tools.

The machining was done in the **Hermle C22U 5 axis-milling machine**, which provides the stability that is of special importance for ceramic tools. After various tests, the results were:

Traditional tools:	1260 seconds (21 minutes)
Ceramic tools:	27 seconds = 42 times faster
Price reduction:	factor 6.6 cheaper milling with ceramic tools than traditional tools.
